## North of 60

# Report on Municipal Services in Communities of the Northwest Territories NSRG 73-1

By G. W. Heinke

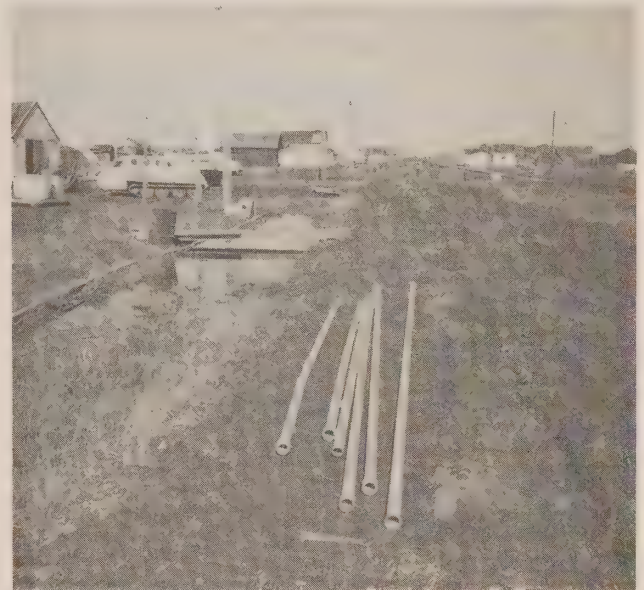
To prevent damage to the pipe by freezing, the system is taken out of service in the fall, and the pipes disconnected and left in place for reconnection the following spring (Photo A-7). Considerable breakage of valves occurs in handling, and the pipes may be filled with a variety of materials by industrious children. Placing the pipes on a set grade and providing hydrants and valves to permit drainage without dismantling has been suggested by Grainge, (1970f). This would be preferable to complete removal and storage of the piping, as even greater damage would be likely to occur than at present.

PHOTO A-7—Unused piping for summer distribution system

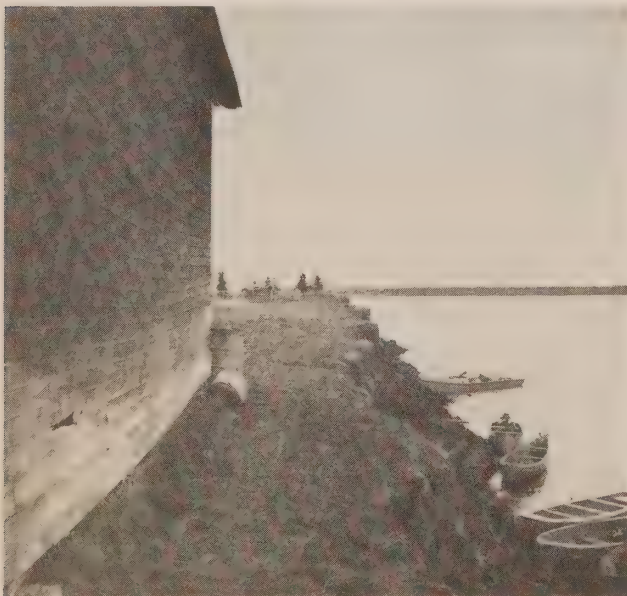
PHOTO A-12—Erosion of south bank

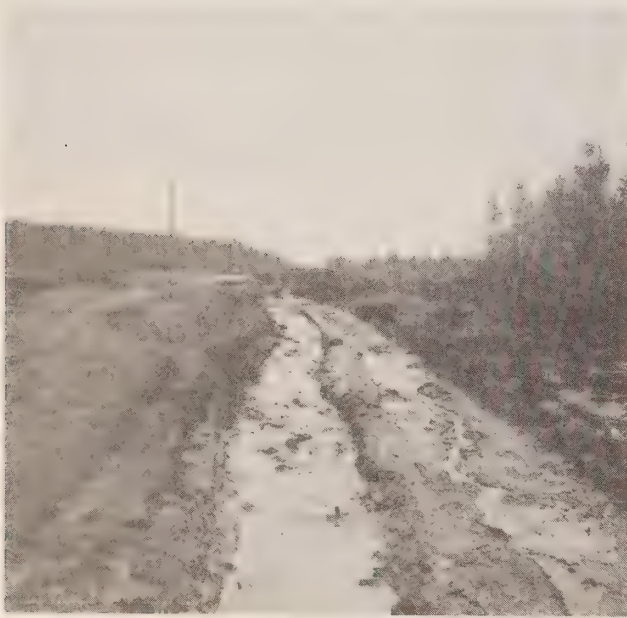
PHOTO ARR-4—Destruction of permafrost along CNT road

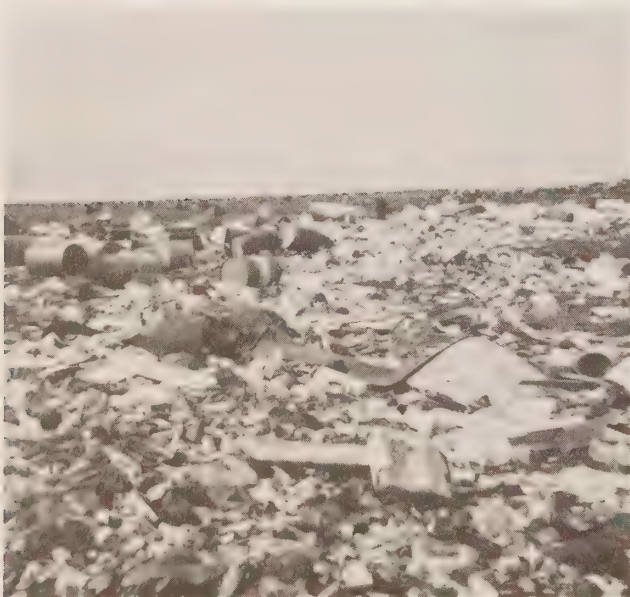
PHOTO BL-9— Part of the dump.

Dumping is not organized ; the vehicle drives to a convenient spot and the drums are dumped or thrown off the cart. Much paper and many broken honey bags have blown into the surrounding tundra. At the time of dumping, damaged drums are replaced from the large supply of empty gasoline and oil drums at the dump.

- The time required for pump-out of each sewage tank should be determined, and that procedure followed.
- Until a more suitable site is found for the dump, the present site should be bulldozed, compacted, and covered with gravel. The settlement will require equipment (bulldozer) to do this. Subsequent dumping should be more restricted so that the dump does not again assume its present mammoth proportions.

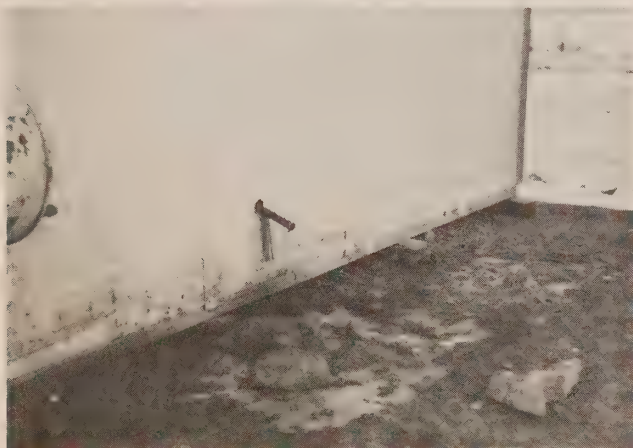
Kitchen liquid waste and wash water from Eskimo homes spills directly onto the gravelly terrain around the houses (Photo CB-4). The nurse in charge could not specifically attribute any middle ear or throat infections to this practice.

PHOTO CB-4—Waste-water pipe beside Eskimo home. (Kitchen liquid waste and wash water)

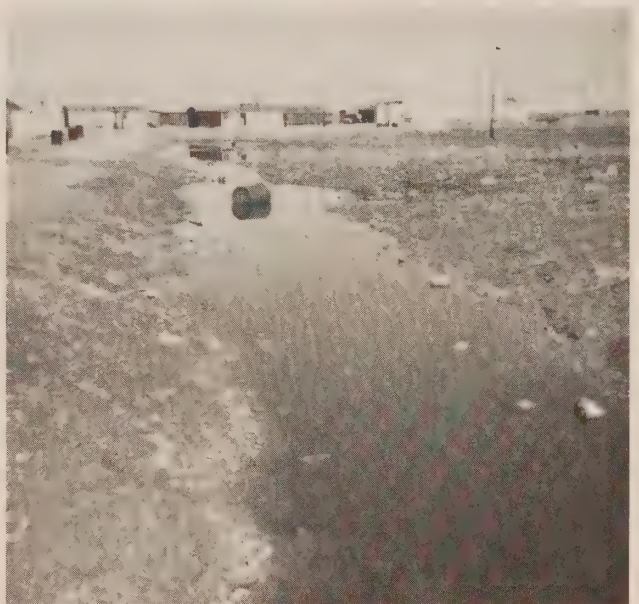
PHOTO CB-10—Drainage problem at town recreational area.

A road improvement program with a \$10,000 budget has been proposed. It will permit the replacement of oil drum culverts, some of which are collapsing, the installation of new culverts where needed, ditching around the settlement centre, and filling and drainage to increase lot levels and prevent spring flooding.

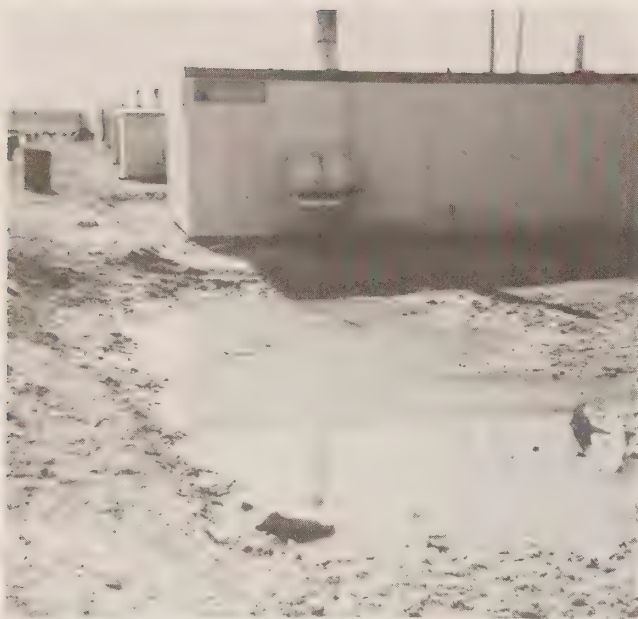
The natural drainage around Cambridge Bay is relatively good, on account of the gravelly soil, although the building of roads without culverts or with badly placed culverts has caused some drainage problems (Photo CB-10). In spring some homes are surrounded by water, both runoff and melted liquid wastes (Photo CB-11).

PHOTO CB-11 – Drainage problem beside home.

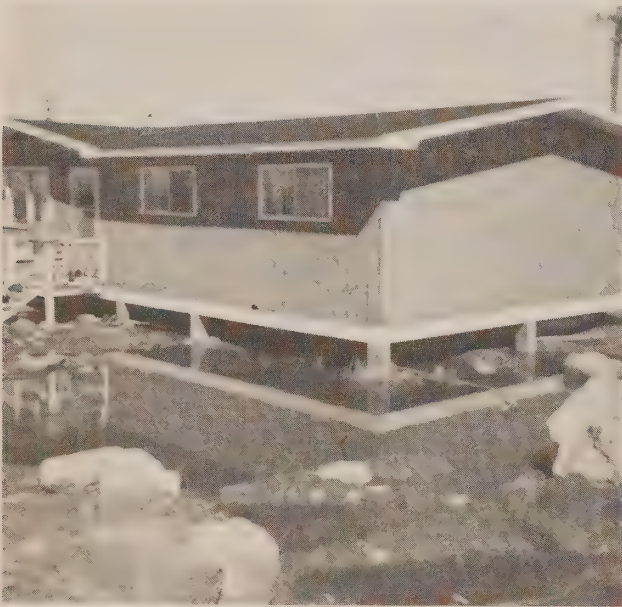
The town has serious problems with drainage. The rocky terrain does not allow the absorption of water into the soil; the spring run-off is held in numerous puddles by the road embankments (Photo C-10). In the low-rental unit district, the roads are one to two feet above the lots and act as dykes to hold the water in. Residents report that they must depend on planking to reach their homes in spring. During the site inspection, the ground was still soft and muddy in many places.

PHOTO C-10—Water under house, restrained by dyke.

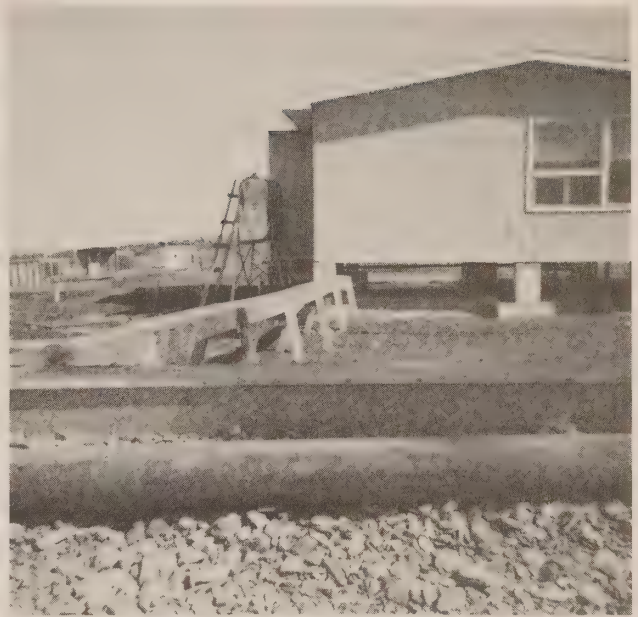
This inadequate drainage is further aggravated by the accumulation of wash water and kitchen waste water around the houses. Sink drainage pipes discharge beneath all houses. The waste water often contains animal and vegetable matter which decays after spring thaw adding to the already pungent odour of the contents of broken honey bags. The waste water problem is especially great under the three NCPC houses (Photo C-11) serviced by the utilidor, where ice two feet thick remained even in late June. The estimated 30,000

PHOTO C-11—Two-foot layer of ice under house connected to utilidor.

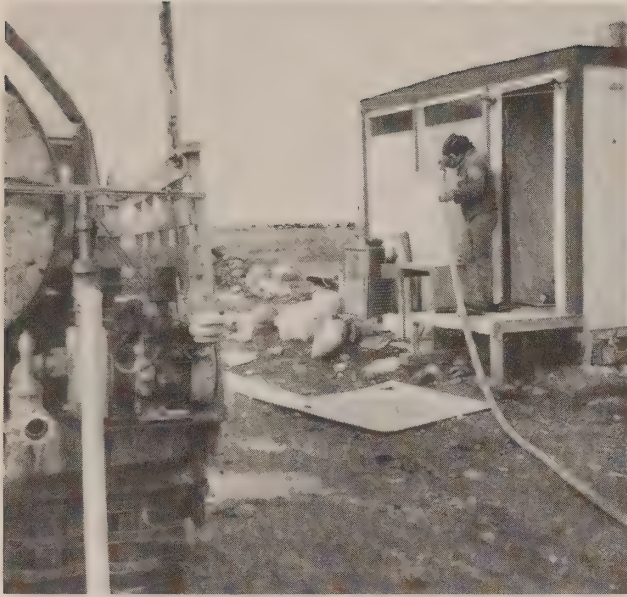
- The nozzle has no supply regulator valve; when the tank is full, the hose must be kinked to stop the flow of water. More serious: during the refolding of the hose after each filling, the nozzle is allowed to drag along the ground through puddles, garbage, and honey bag debris.

PHOTO EP-3—Water delivery to an Eskimo home. Note : tank uncovered, outside home.

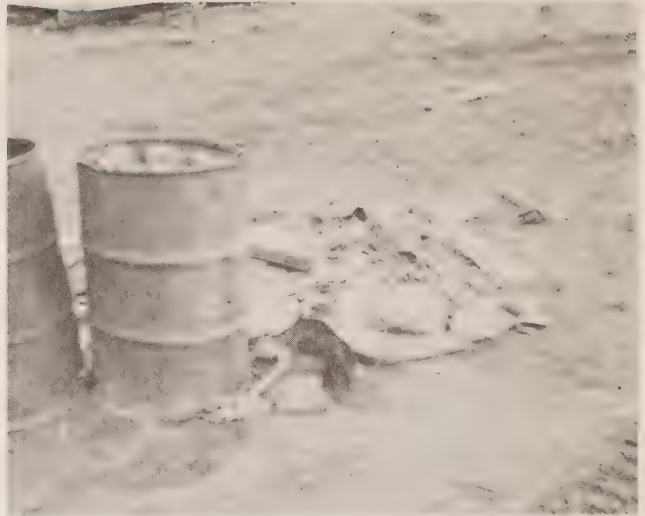
Garbage and honey bags are collected in a 6 foot by 8 foot by 3 foot high cart pulled by the Nodwell. At each home, all three men help to lift drums containing dry garbage onto the cart for dumping (Photo EP-7). Honey bags are removed by hand. (Photo EP-8) and thrown onto the truck. During the handling operation, many break, dripping their contents through leaks in the cart onto the ground in the settlement. Liquid in the cans is dumped into the cart, from which it, too, leaks out.

PHOTO EP-6—Garbage, honey-bags and dog.

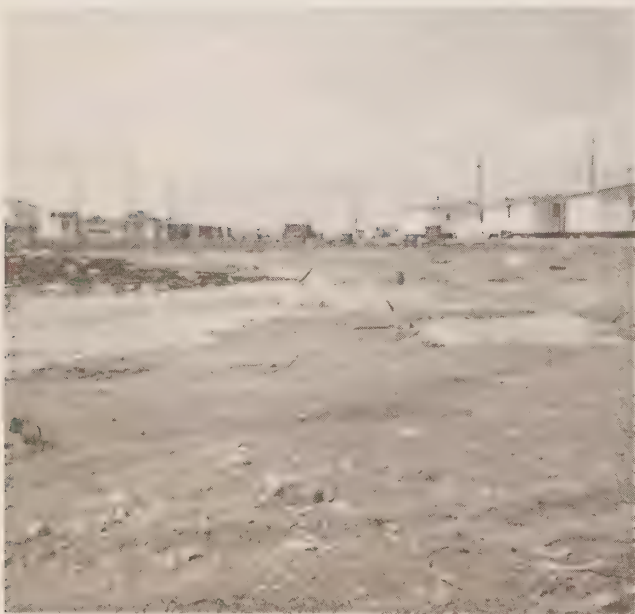
PHOTO EP-13—Poorly drained residential area.

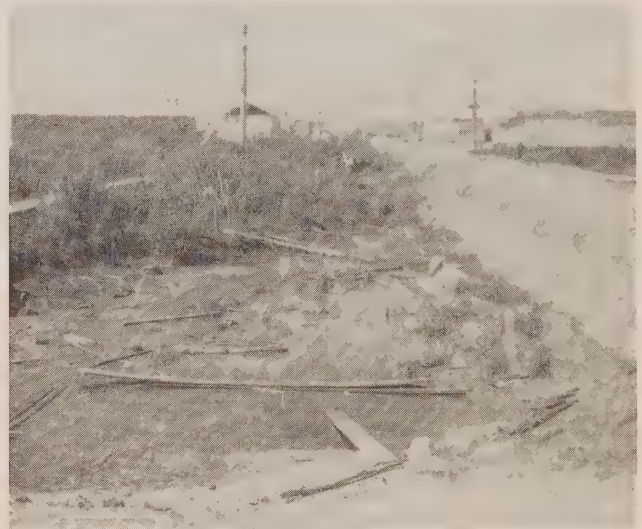
PHOTO FM-8 – Result of a blocked culvert.

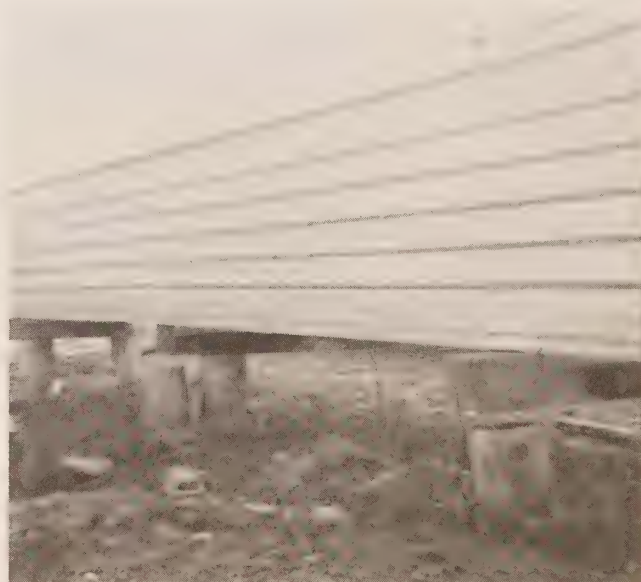
PHOTO IN-2 - The original utilidor lifted by frost action. The pile in the foreground has remained stable while the adjacent piles heaved. The gap is 2" wide. Standing pools of water (to the left in the photograph) may have contributed to the problem of pile heaving.

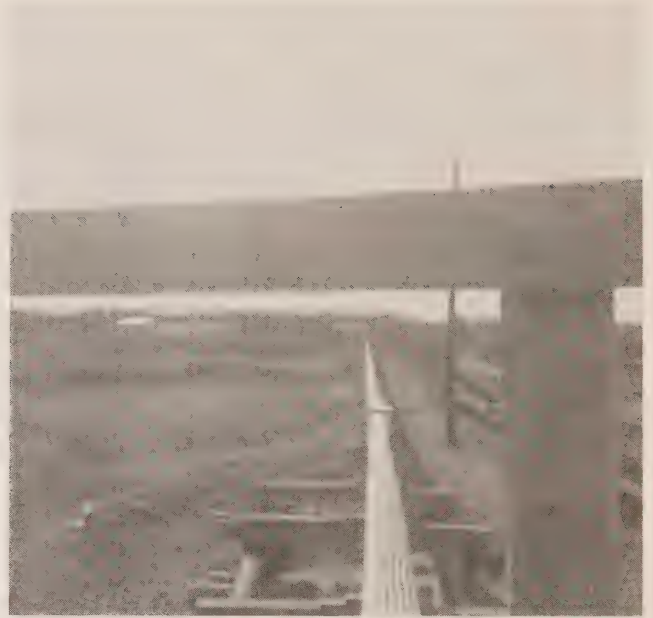
PHOTO IN-6—The twisted sewage outfall line caused by down-slope movement of thawing perennially frozen soils which were exposed in a side hill cut.

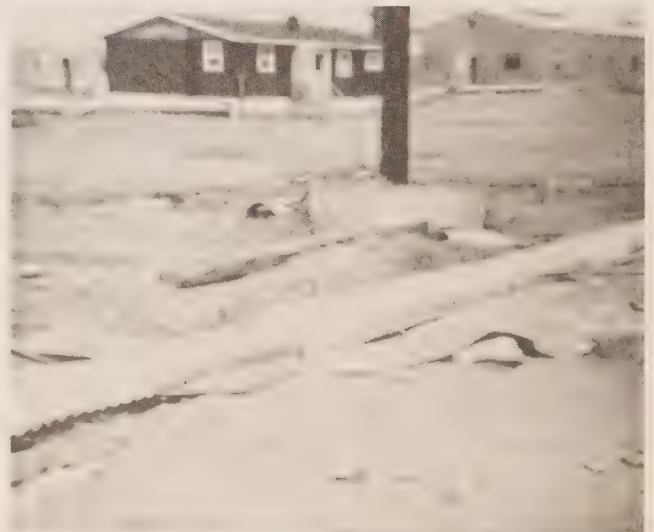
PHOTO RI-5—Utilidor structure damaged by "traffic".

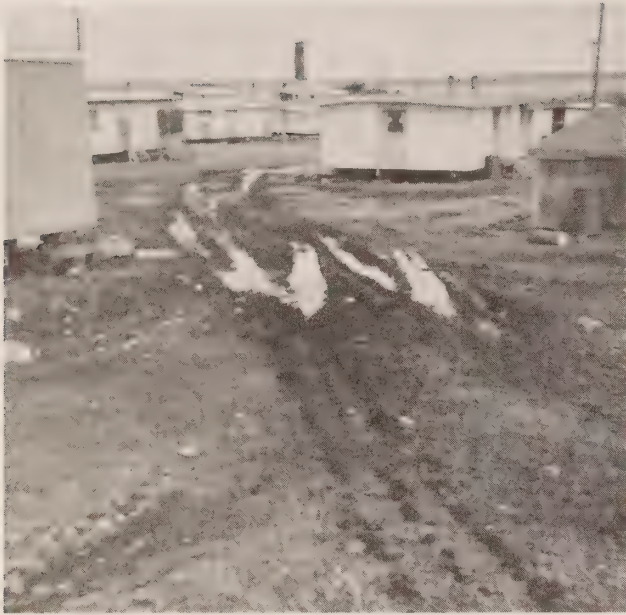
PHOTO RI-14—Drainage problem.

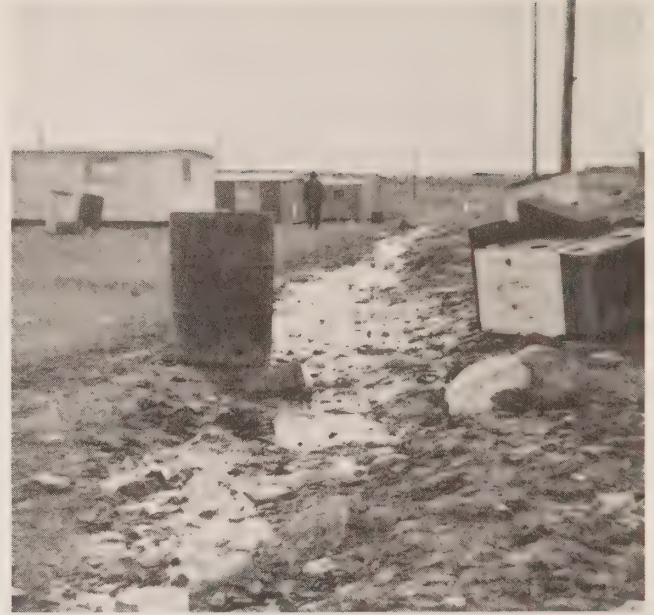
PHOTO RI-15—Drainage "ditch".
